Manual TP-0445

Parts Failure Analysis

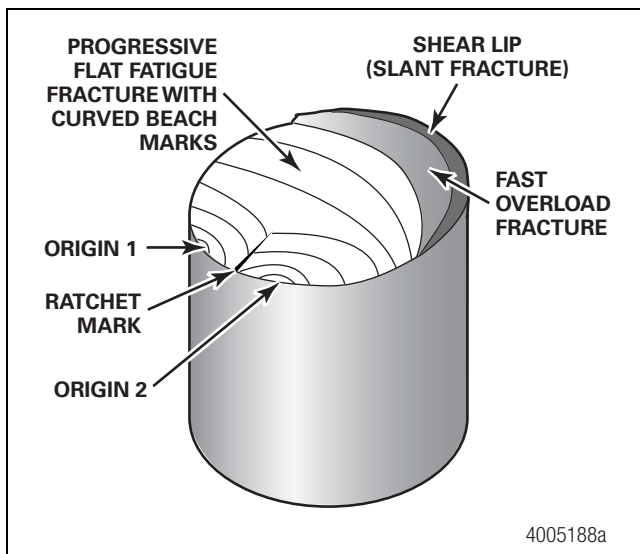
Figure 3.1

Beach marks represent fatigue cycles that occurred before the component failed completely. Visually, beach marks are often compared to the rippling effect of a stone thrown into calm water. Figure 3.1.

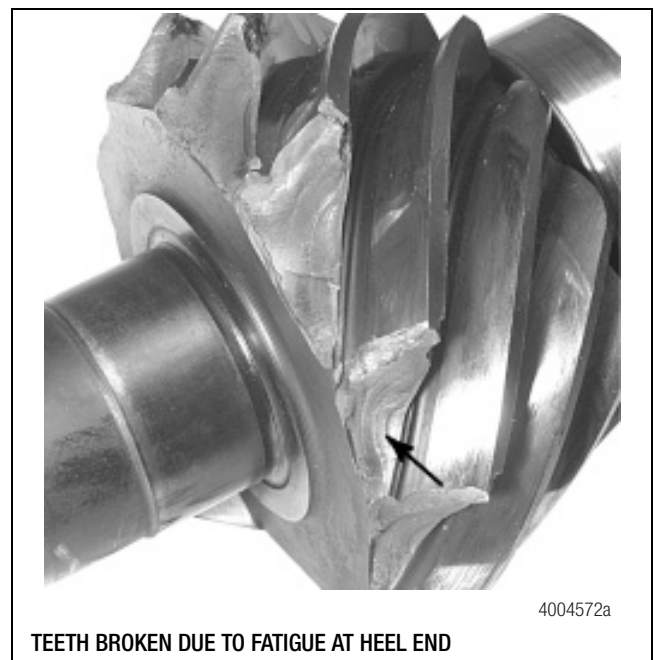
Bending fatigue also causes gears to change position, which affects tooth contact patterns. Figure 3.3 shows concentrated loading at gear teeth corners instead of over the entire surface. Figure 3.4 shows two tooth patterns on the ring gear, because bending fatigue caused the gear to change position.

TEETH BROKEN DUE TO FATIGUE AT HEEL END

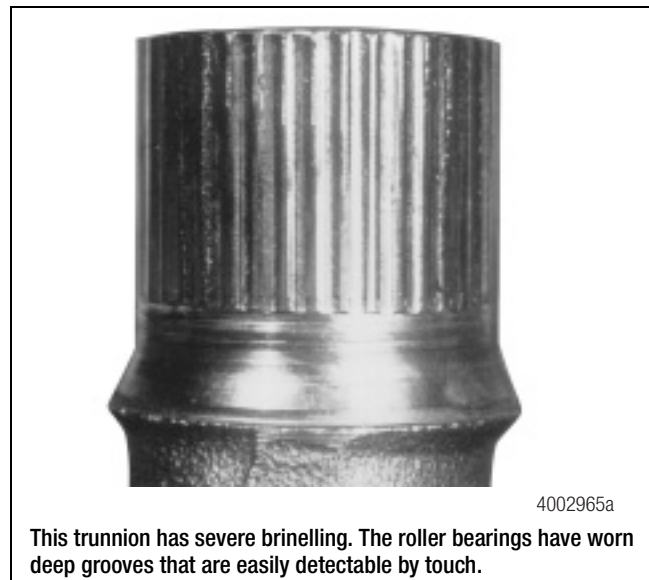
Figure 3.6

Brinelling is a type of surface fatigue that causes bearing rollers to wear deep grooves into the mating surface. Figure 3.6. Brinelling of a u-joint usually occurs when load applications exceed the vehicle's rating, which can also cause parts to spall from uneven load application.

Brinelling can also be caused by overloads on undersized u-joints and by a breakdown of lubricant between the needle rollers and trunnion. To determine if the condition you see is brinelling, check the trunnions with your fingertips. Do you feel deep grooves? If so, brinelling has occurred.

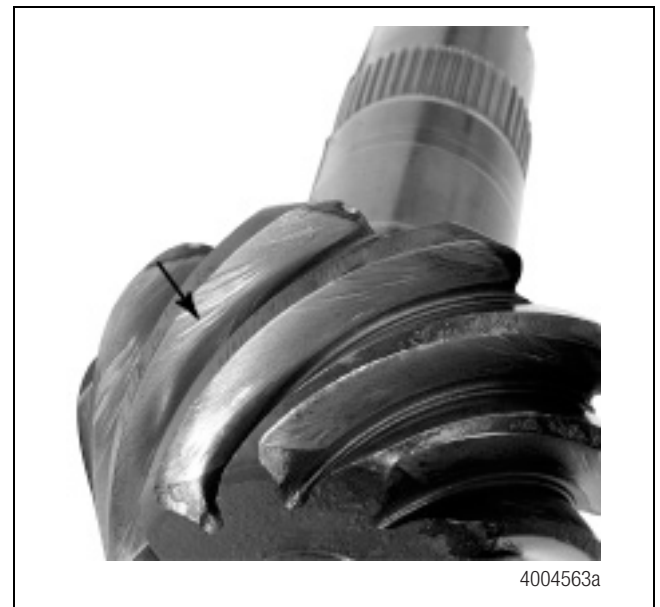
Metal-to-metal contact occurs, which causes friction to damage parts. Figure 3.9 and Figure 3.10.

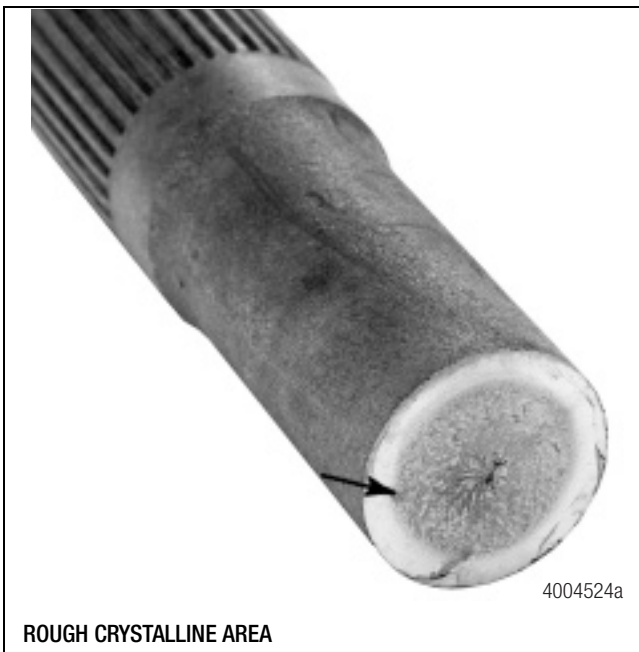
Figure 3.11

When a sudden, severe impact load occurs, the wear pattern that forms on the surface of the part resembles crystal facets. Figure 3.11.

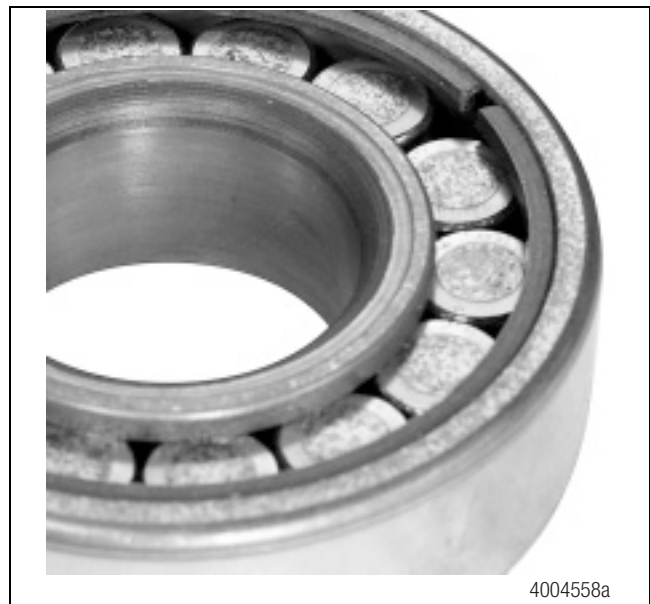
Water in lubricant damages bearing races and cups, and causes the hypoid gear set to wear prematurely. Figure 3.12 shows corrosion on the spigot bearing roller ends. Figure 3.13 shows etching damage on the bearing rollers, non-contact surfaces and bearing cage windows.

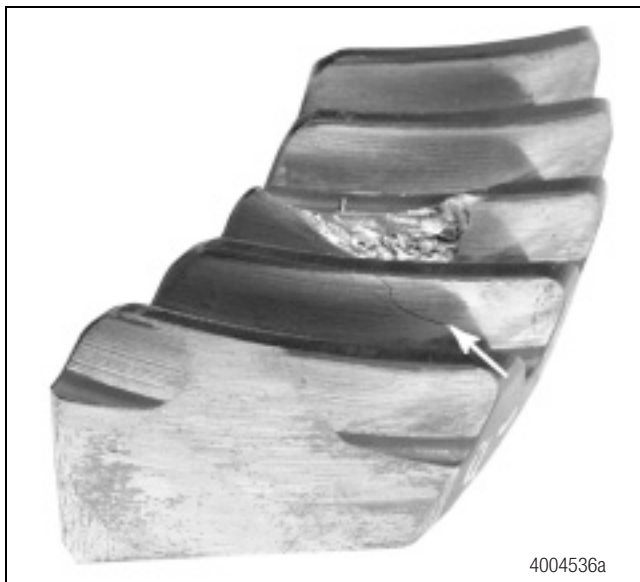
Figure 3.14

Flank cracking is a type of surface fatigue that's similar to spalling, because it causes metal to break into chips or fragments. When flank cracking occurs, initially cracks form along the length of the gear tooth. Once flank cracking appears, the tooth begins to crumble, and failure rapidly occurs. Figure 3.14.

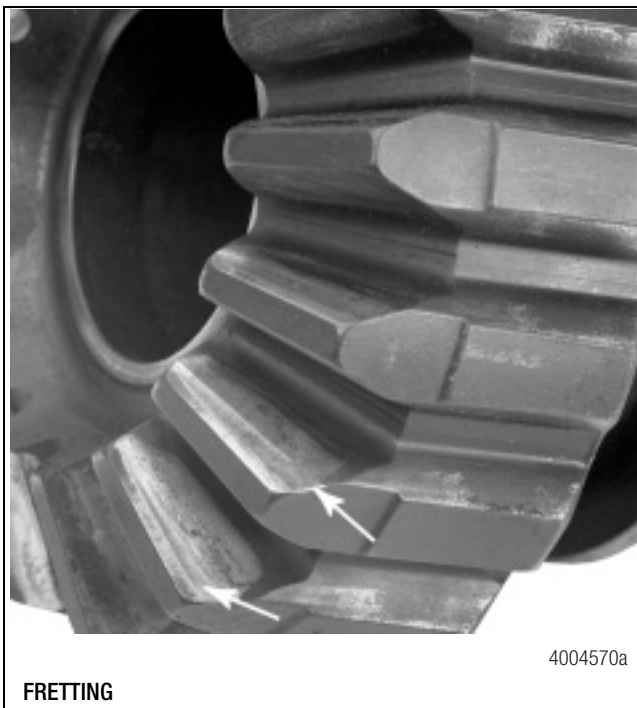
Figure 3.16

Inspect the back of the gear teeth on the forward drive axle carrier. If you find a contact line on the rear side of the gear teeth on the forward drive axle carrier, fretting has occurred. Figure 3.16.

FRETTING

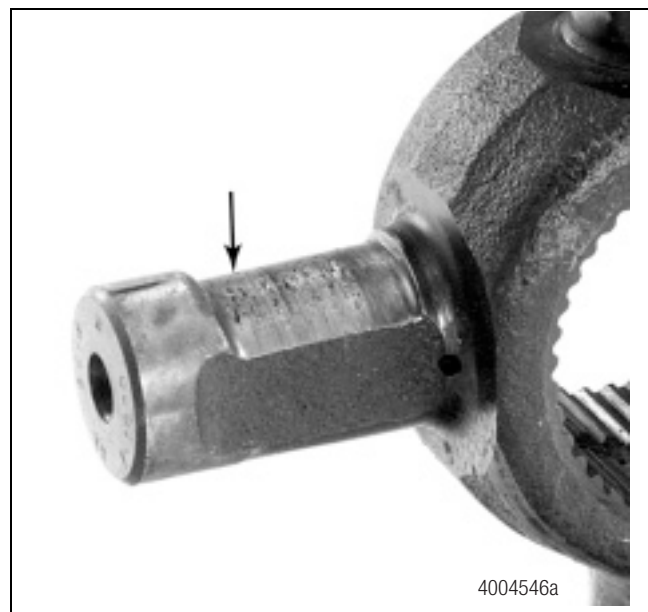
Figure 3.17

Galling, a type of surface fatigue that occurs when two unlubricated metal surfaces rub against each other. Galling is also called "metal transfer." Figure 3.17.

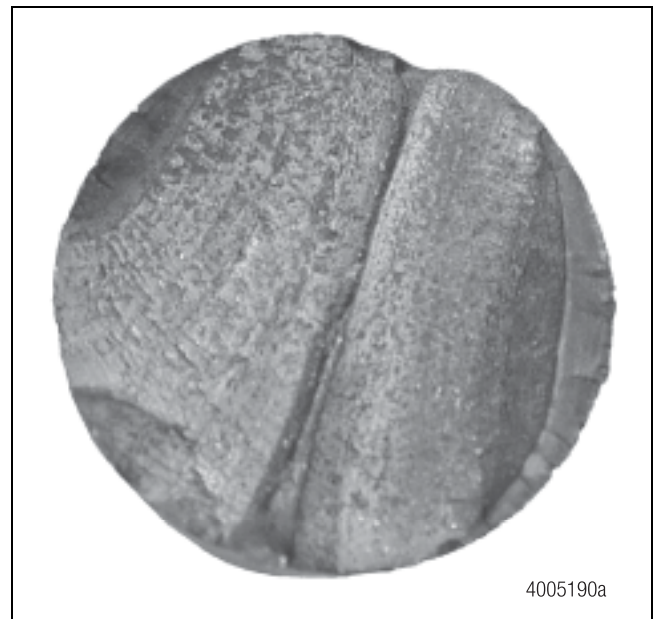
Figure 3.24

Reverse bending is a type of fatigue that breaks a component in two directions, 180 degrees apart. Beach marks occur on each side of the fractured area and move toward the center of the component. Figure 3.24.

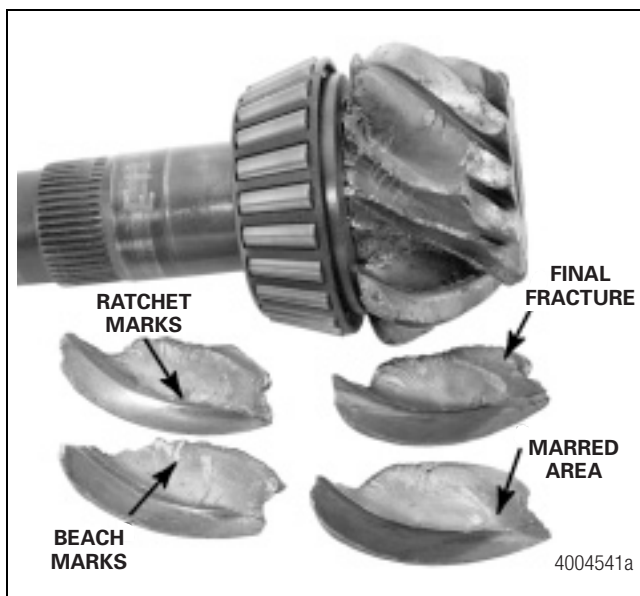
Figure 3.25 shows a less common root beam fatigue fracture that occurred when shock load was strong enough to crack the tooth, but not to break the entire tooth.

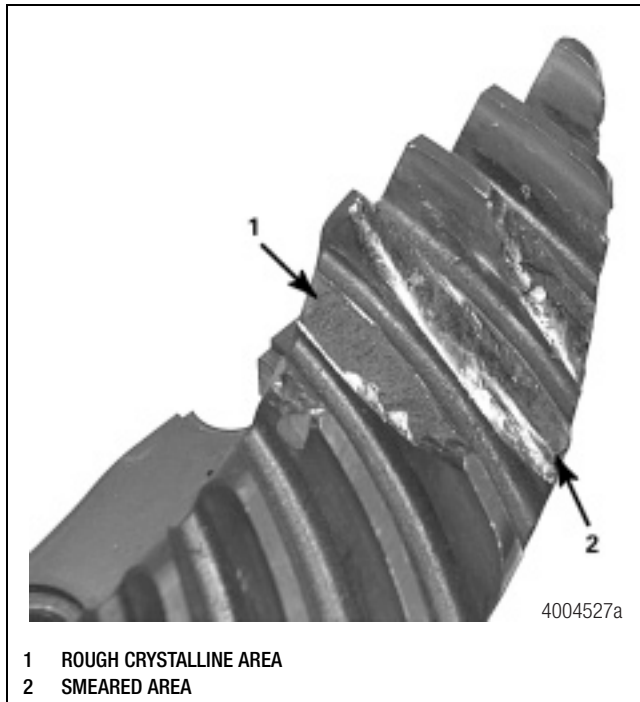
Figure 3.27 shows a hypoid gear seat damaged by shock load. Typically, the first tooth breaks at the heel, the second tooth breaks completely, and the third tooth breaks at the toe. The figure shows how two of the teeth were damaged by the pinion rubbing against the area where the teeth broke.

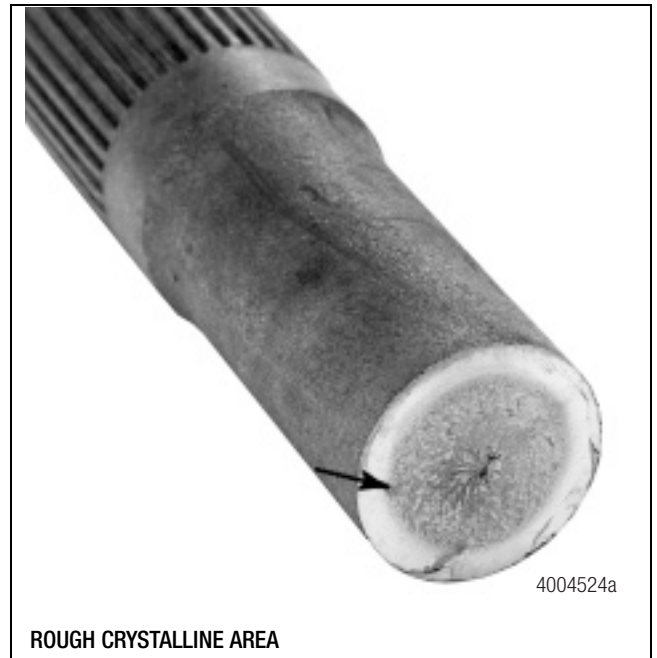
Figure 3.28 and Figure 3.29 show an axle shaft damaged by shock load that fractured perpendicular to its centerline, which caused a rough, crystalline surface to form on the shaft. This type of failure is also called “torsional shear.” If the fracture is at a 45-degree angle to the centerline, the damage is called “torsional tensile” failure.

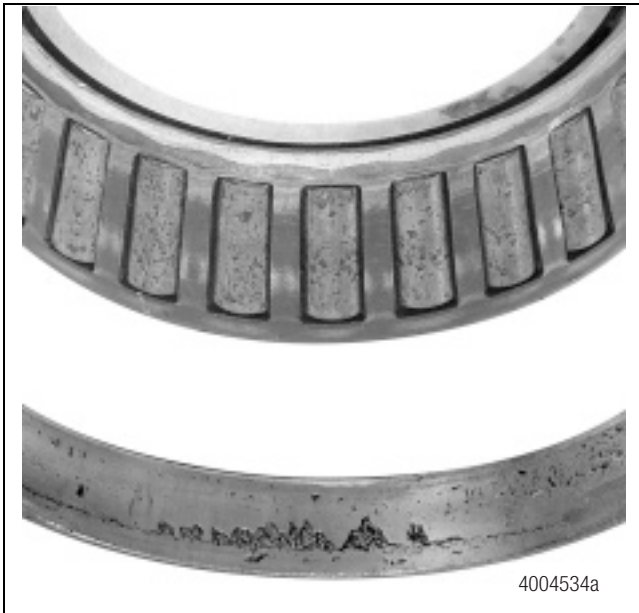
Some causes of spalling are prolonged stress from excessive load applications; or the components operate with no lubricant or a lubricant that doesn't meet the correct specification. Spalling can also occur when components are operated beyond the maximum mileage range. Figure 3.30 and Figure 3.31.

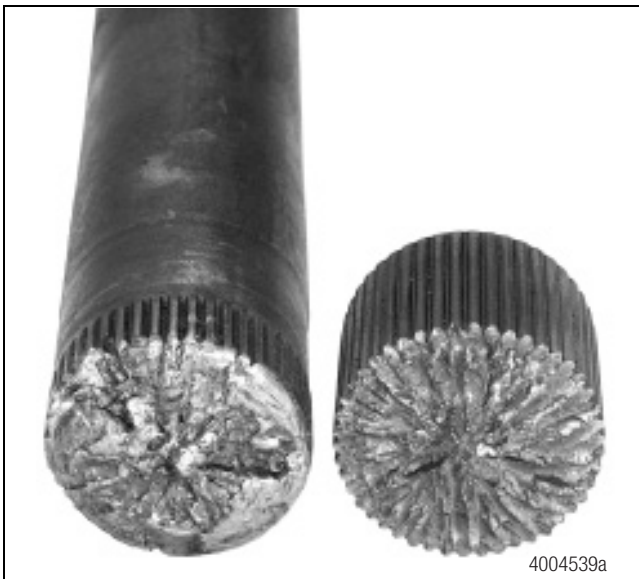
Unlike bending fatigue, torsional fatigue causes excessive twisting that weakens components. Usually, you'll see beach marks and ratchet marks at the fracture's origin point. However, if torsional fatigue occurs on a splined shaft, you'll see that the fracture started at the base of each spline. Figure 3.36 shows a drive shaft damaged by torsional fatigue. As the splines continued to weaken, the metal formed a star-shaped radial pattern, eventually breaking the shaft at the center.

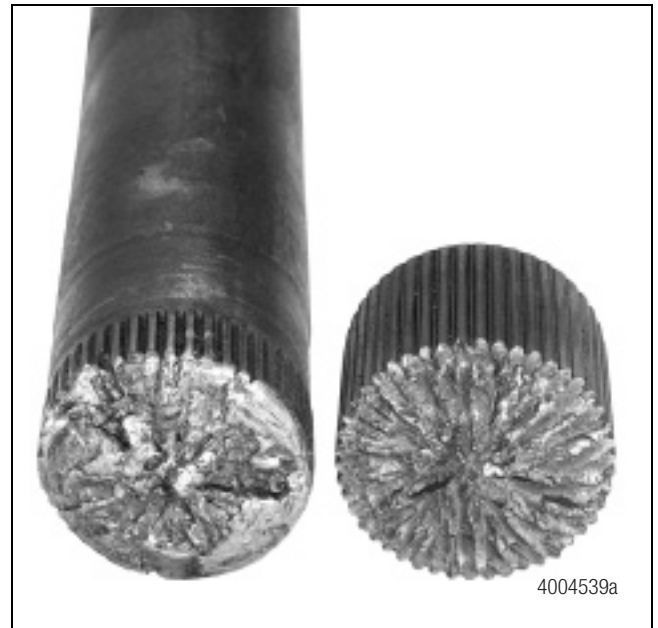
Figure 4.5 shows a shaft damaged by torsional fatigue. As the splines continued to weaken, the metal formed a star-shaped radial pattern, eventually breaking the shaft at the center.

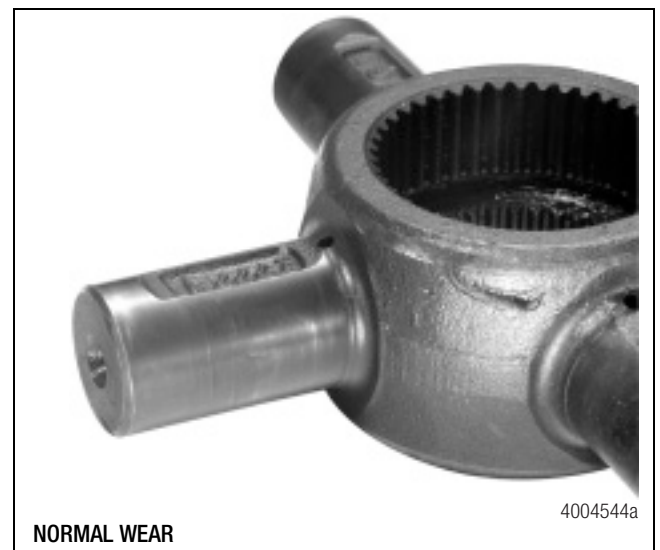
Figure 4.12

Figure 4.12, Figure 4.13, Figure 4.14, Figure 4.15 and Figure 4.16 show how spinout caused a pinion cross to fail. Damage progresses from normal wear, to moderate premature wear, and then to heavy wear; and finally, the pinion cross fails.

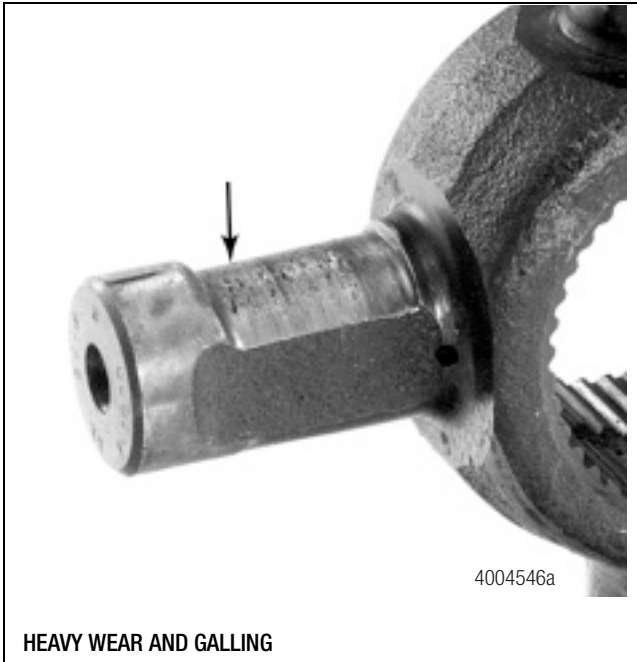
Figure 4.14

HEAVY WEAR AND GALLING

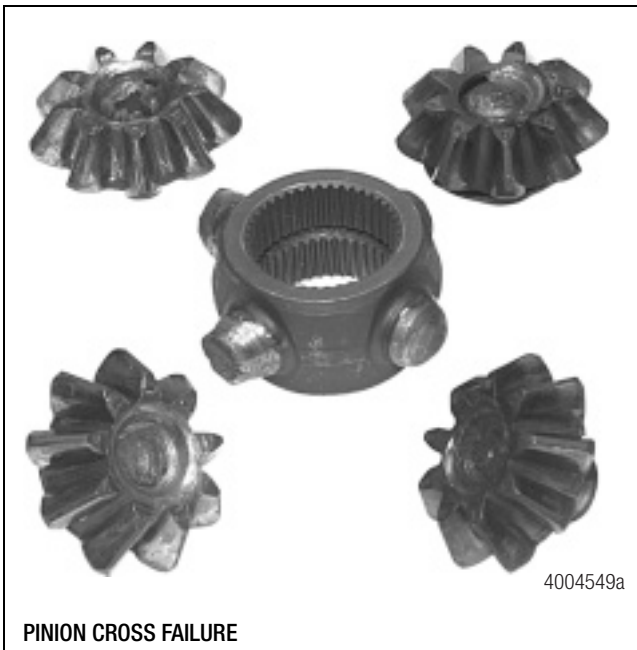
PINION CROSS FAILURE

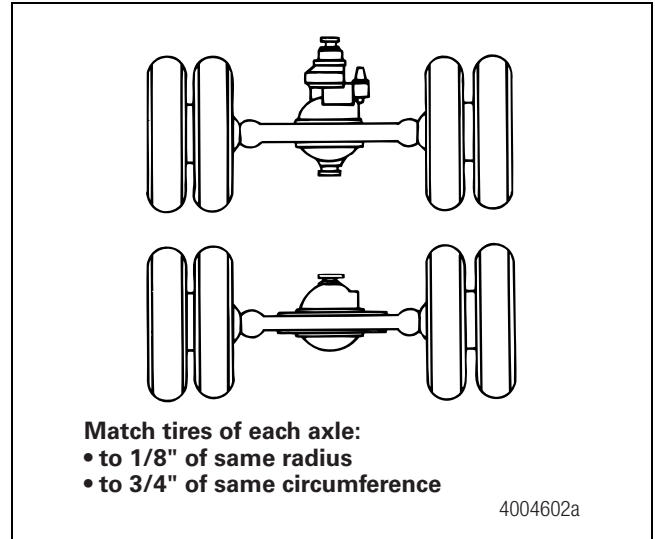
Figure 4.20

Mismatched tire ratios can cause spinout to occur. Meritor recommends matching tires to within 1/8-inch (3.175 mm) of the same rolling radius and 3/4-inch (19.05 mm) of the same rolling circumference. In addition, the total tire circumference of both driving axles should be matched to each other as closely as possible. Figure 4.20.
